## Living Shorelines to Control Erosion, not Rocks

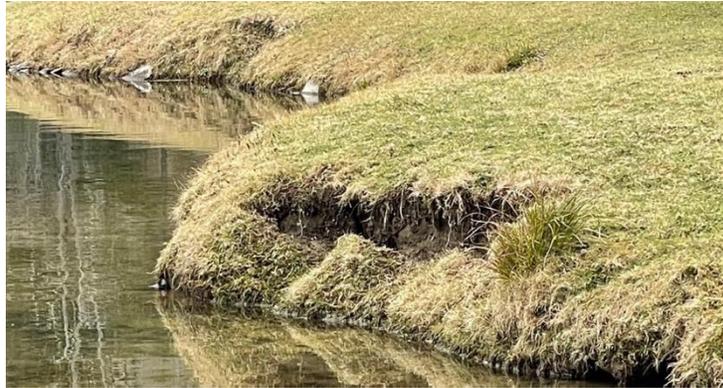
*Shoreline Failure: Lawn down to the lake with bank slumping*

When lawns are maintained all the way to the water's edge, it is a setup for shoreline failure because mowed turf grasses have short roots, resulting in bank slumping, where sections of soil separate, leaving crevasses. Piling rocks on top only leads to more erosion, as the power of the waves has nowhere to go but down and to the sides, scouring the lakebed and neighbors' properties. The loss of native plants on shore and in the water from the rocks and scouring causes algae to thrive as they take up the available nutrient runoff. Each 100 ft of shoreline in lawn leads to at least 100 pounds of algae in the water every year.

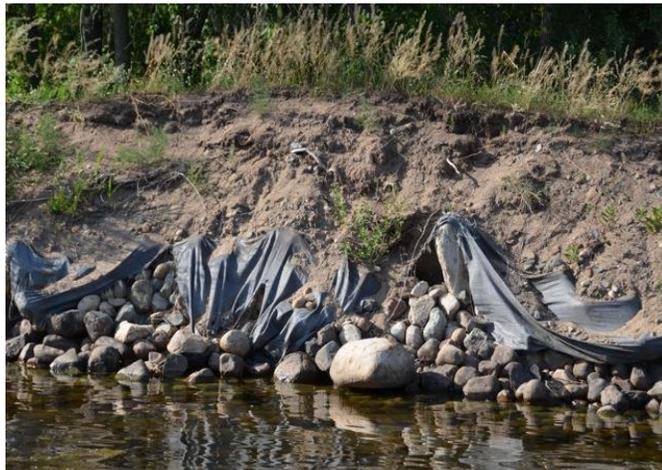
*Riprap can fail from wave action and ice heaves, and rocks are one of the greatest threats to our lakes because of habitat loss leading to poor water quality*

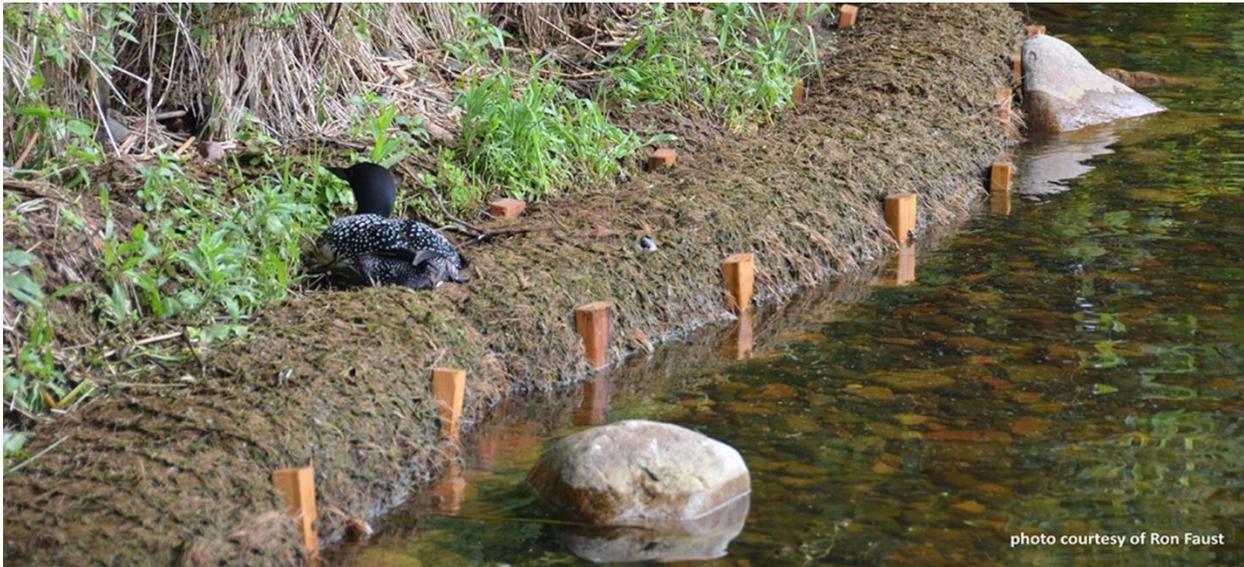
*Shoreline restoration using coconut fiber-based coir logs, restoring habitat for clean water*

The solution is **resilient living shorelines with native plants**. However, if the existing shoreline is mowed lawn, plants will take time to grow and stabilize the shore. **Bioengineering** offers reinforcement with natural materials such as coir logs (pronounced “COY-er”) that are built by rolling plant materials into biodegradable fiber blankets made from coconut husk. (Impermeable plastic sheeting cannot be used because it smothers plant growth.) (See video on Resource page.) Coir logs can actually build more shoreland! And they are less costly. One would think that heavy rocks would protect best, but it is the very fact that **rocks are heavy and unyielding that makes them so damaging** to living shorelines, by scouring and by loss of habitat. And what about shorelines exposed to a broad expanse of water, or “fetch”? See GCOLA’s Summer 2022 Newsmagazine about a successful Lake Steward coir log project on one of the Gull Chain’s most exposed shores. Lake Steward has cost-share funding for shoreline projects that promote clean water and healthy habitat.

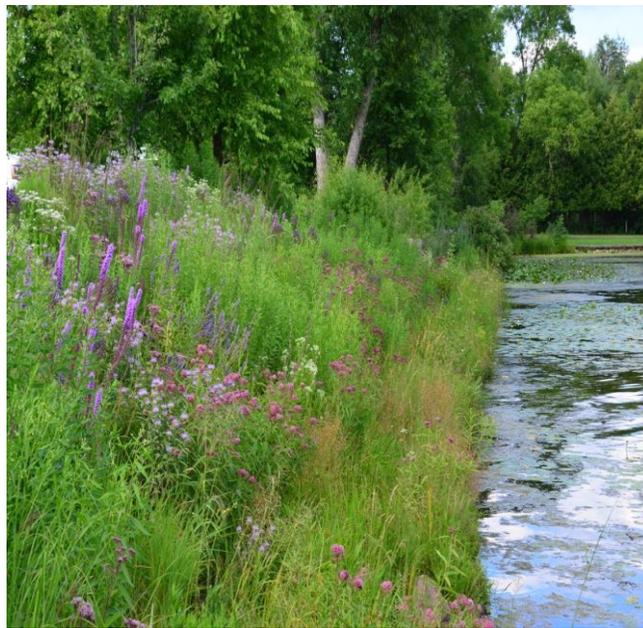
*This living shoreline is powerful and resilient erosion control and provides natural habitat for clean water.*
